BELLINGER RIVER ESTUARY ACTION REACH PLAN

Table of Contents

Introduction

This plan identifies key threats to the Bellinger River Estuary and makes recommendations in regards to actions to address those threats. These recommendations are made at the reach scale and then used to develop a Site Action Plan (SAP) for each property.

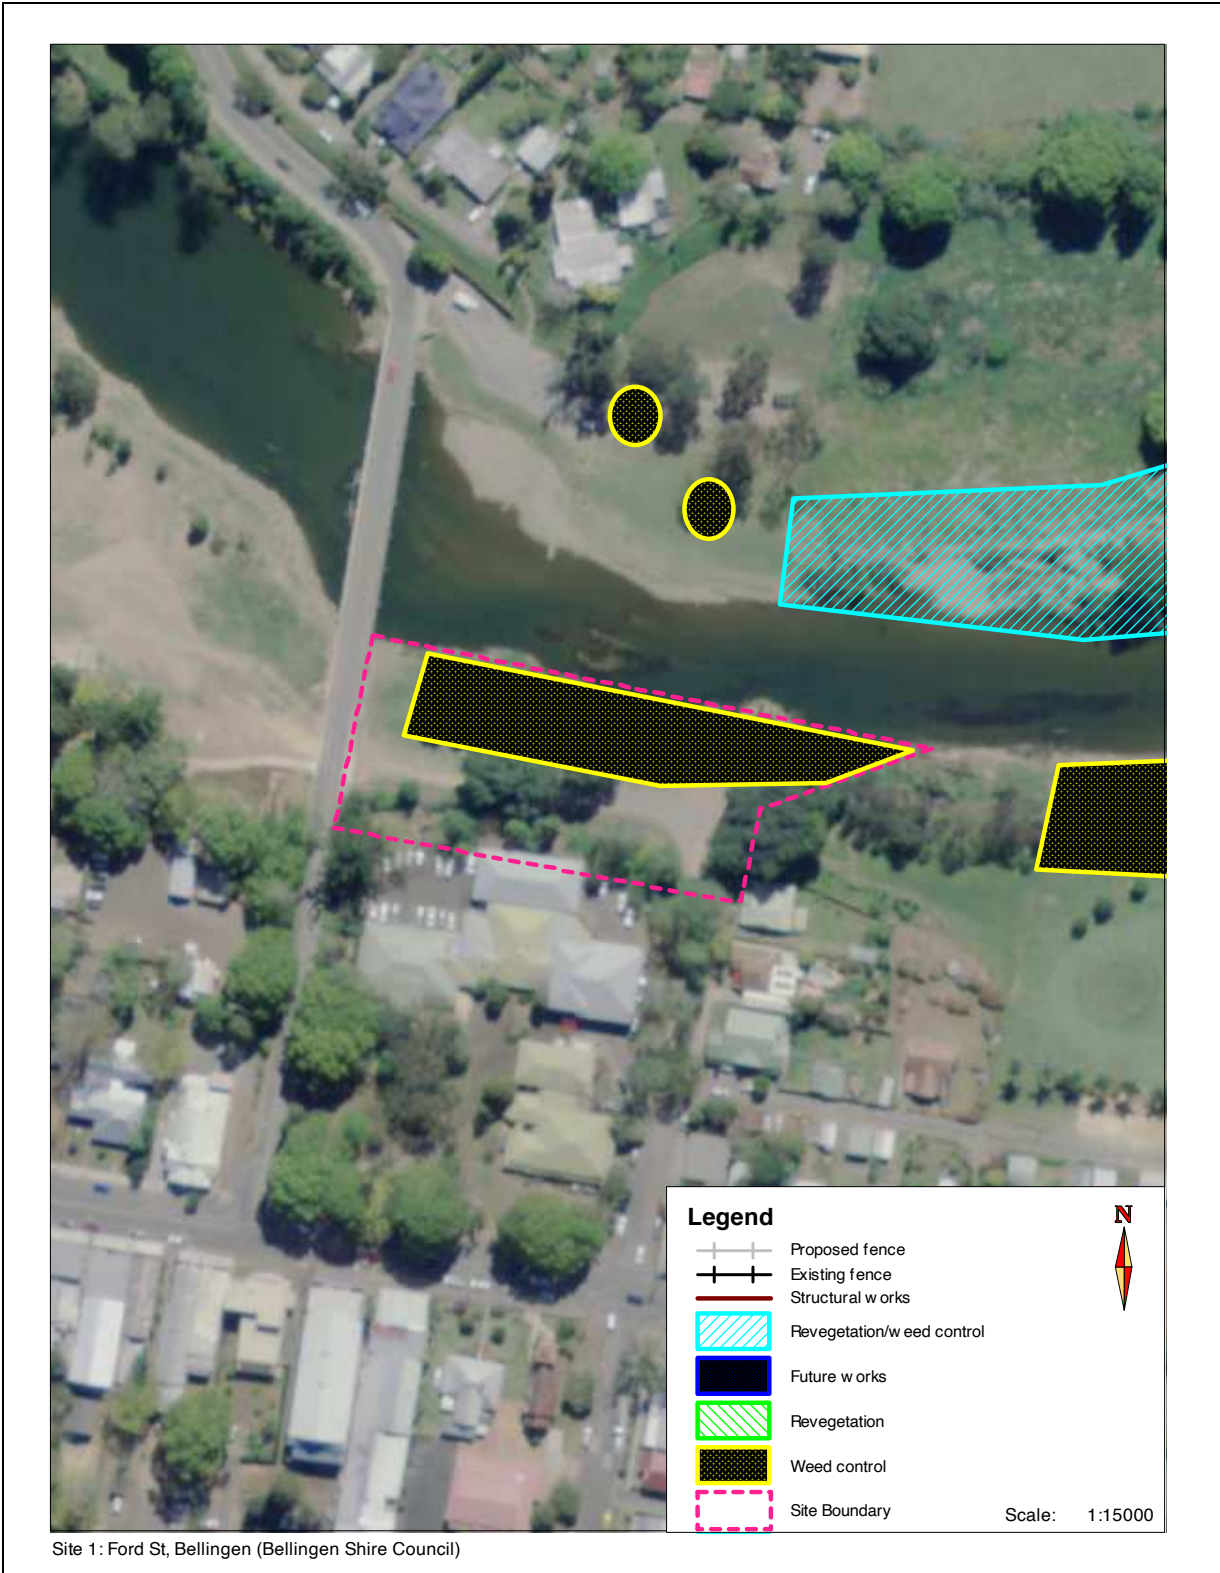
Figure 11: Site workplan map

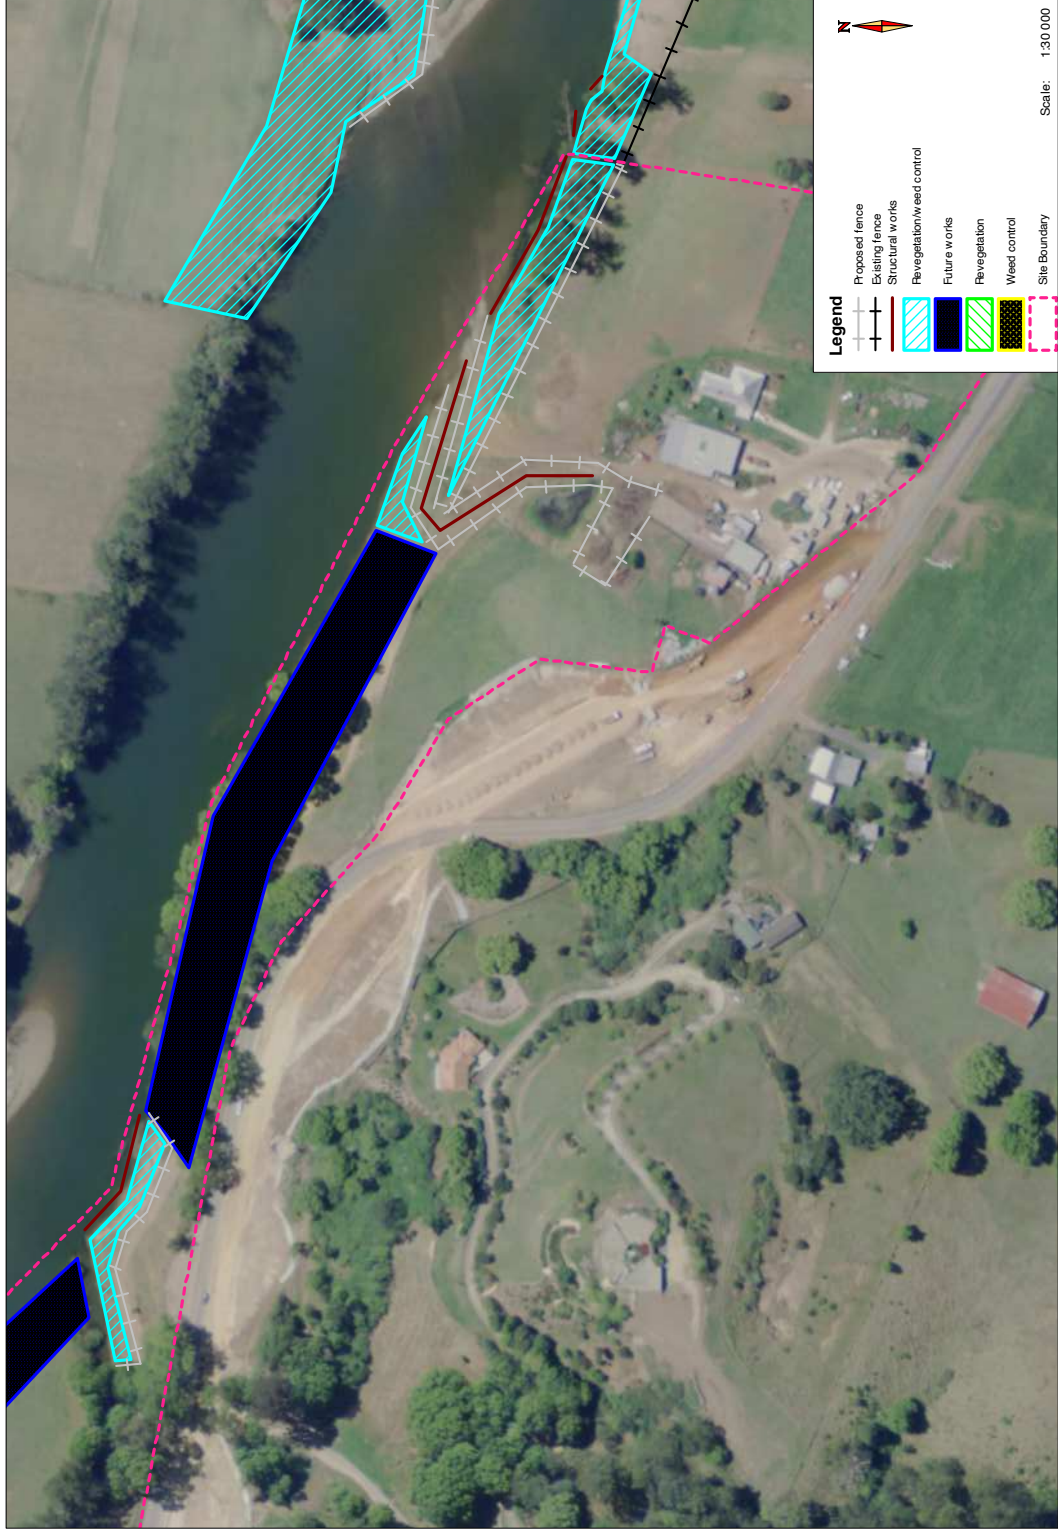
Figure 34: Property workplan map

1. Construction of a new concreted laneway to a restricted river cattle crossing point. The laneway will begin at the dairy on the high bank and run in a v shape across the bank where it will meet the river at the gravel bar. A fence line would be constructed along each margin of the laneway. This will concentrate cattle movement to the laneway to minimize water quality issues and degradation to soil structure in the riparian zone.
2. Two sections of rock revetment are suggested to improve bank stability and susceptibility to mass failure:
 - a. A rock revetment wall should be constructed downstream from the restricted access cattle crossing to meet with the existing revetment wall on the property immediately downstream (zone7). This will alleviate scour and slump issues

- b. A second rock revetment wall is proposed for the severe erosion scald on the outside bend upstream from the bedrock outcropping at Marx Hill (zone 5).
3. It is crucial that both of these sections of revetment are fenced and accompanied by vegetation. A minimum fence line setback of five metres from the crest of the bank is recommended. Within this area, accompanying revegetation using species outlined in the Bellinger River Estuary Revegetation Guide (BSC/Bellinger Landcare) will be critical to ensuring flood resilience over the long term. Root complexes provided by the vegetation strip will bind the mid-upper bank and minimise the potential for outflanking behind the revetment structure during floods. Ongoing weed management will also be critical to ensure the survival and recruitment of native plants.

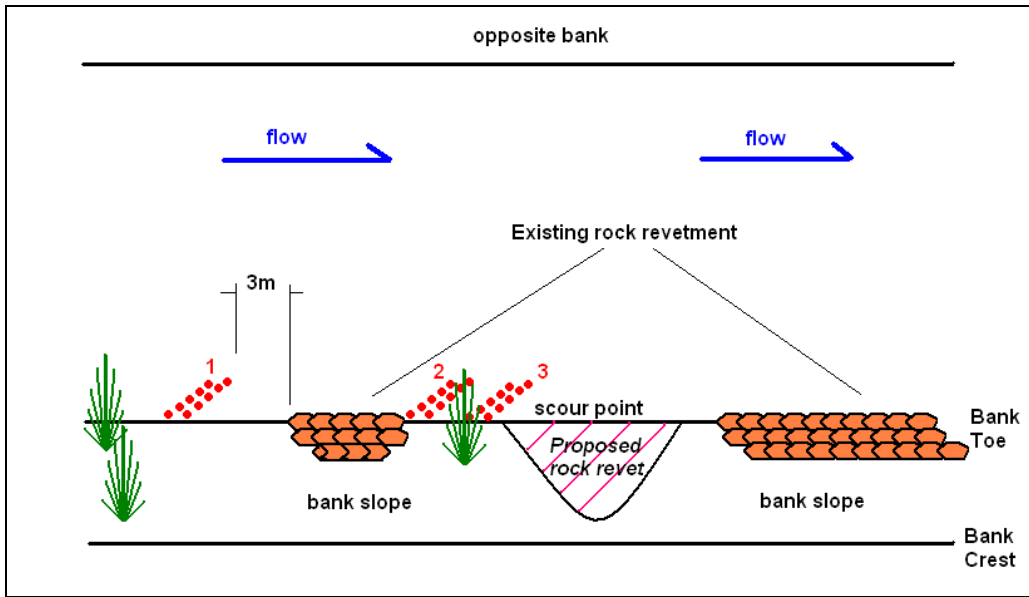
Figure 38: Design and layout for structural works

The rehabilitation strategy should focus on recreating a riparian buffer with deep rooted plant species. This should be accompanied by additional structural works to increase hydraulic roughness and stabilize the bank upstream of the revetment wall. Initial structural works would include installation of double pin sets and rock revetment to deflect flows away from defined scour points and stabilise adjacent banks (see figure x). Following structural works the bank face would be revegetated with a mix of plants as outlined in the Bellinger River Estuary Revegetation Guide (BSC/Bellinger Landcare). A minimum vegetation width of five metres back from the bank crest is recommended to maximize resilience against future flood events. This buffer may need to be re-established and/or expanded in the advent of damaging flood events hampering successful plant establishment.

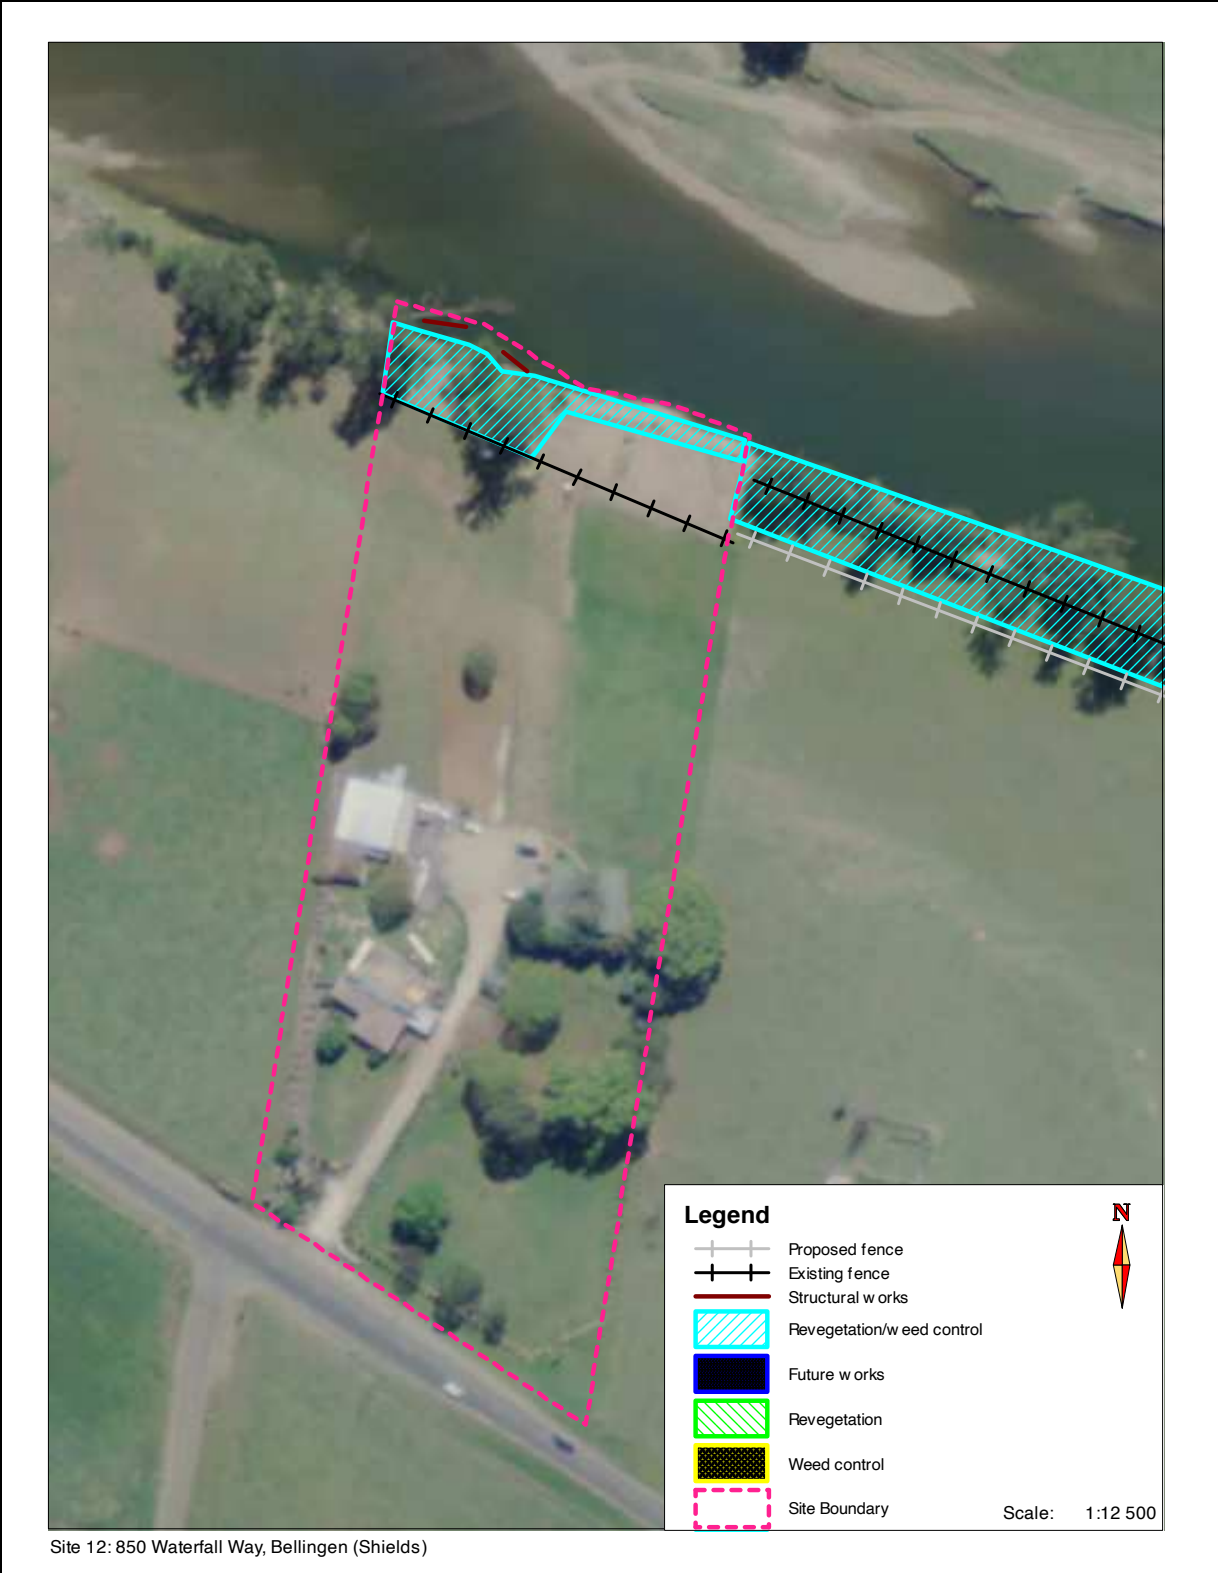
Figure 39: Site workplan map

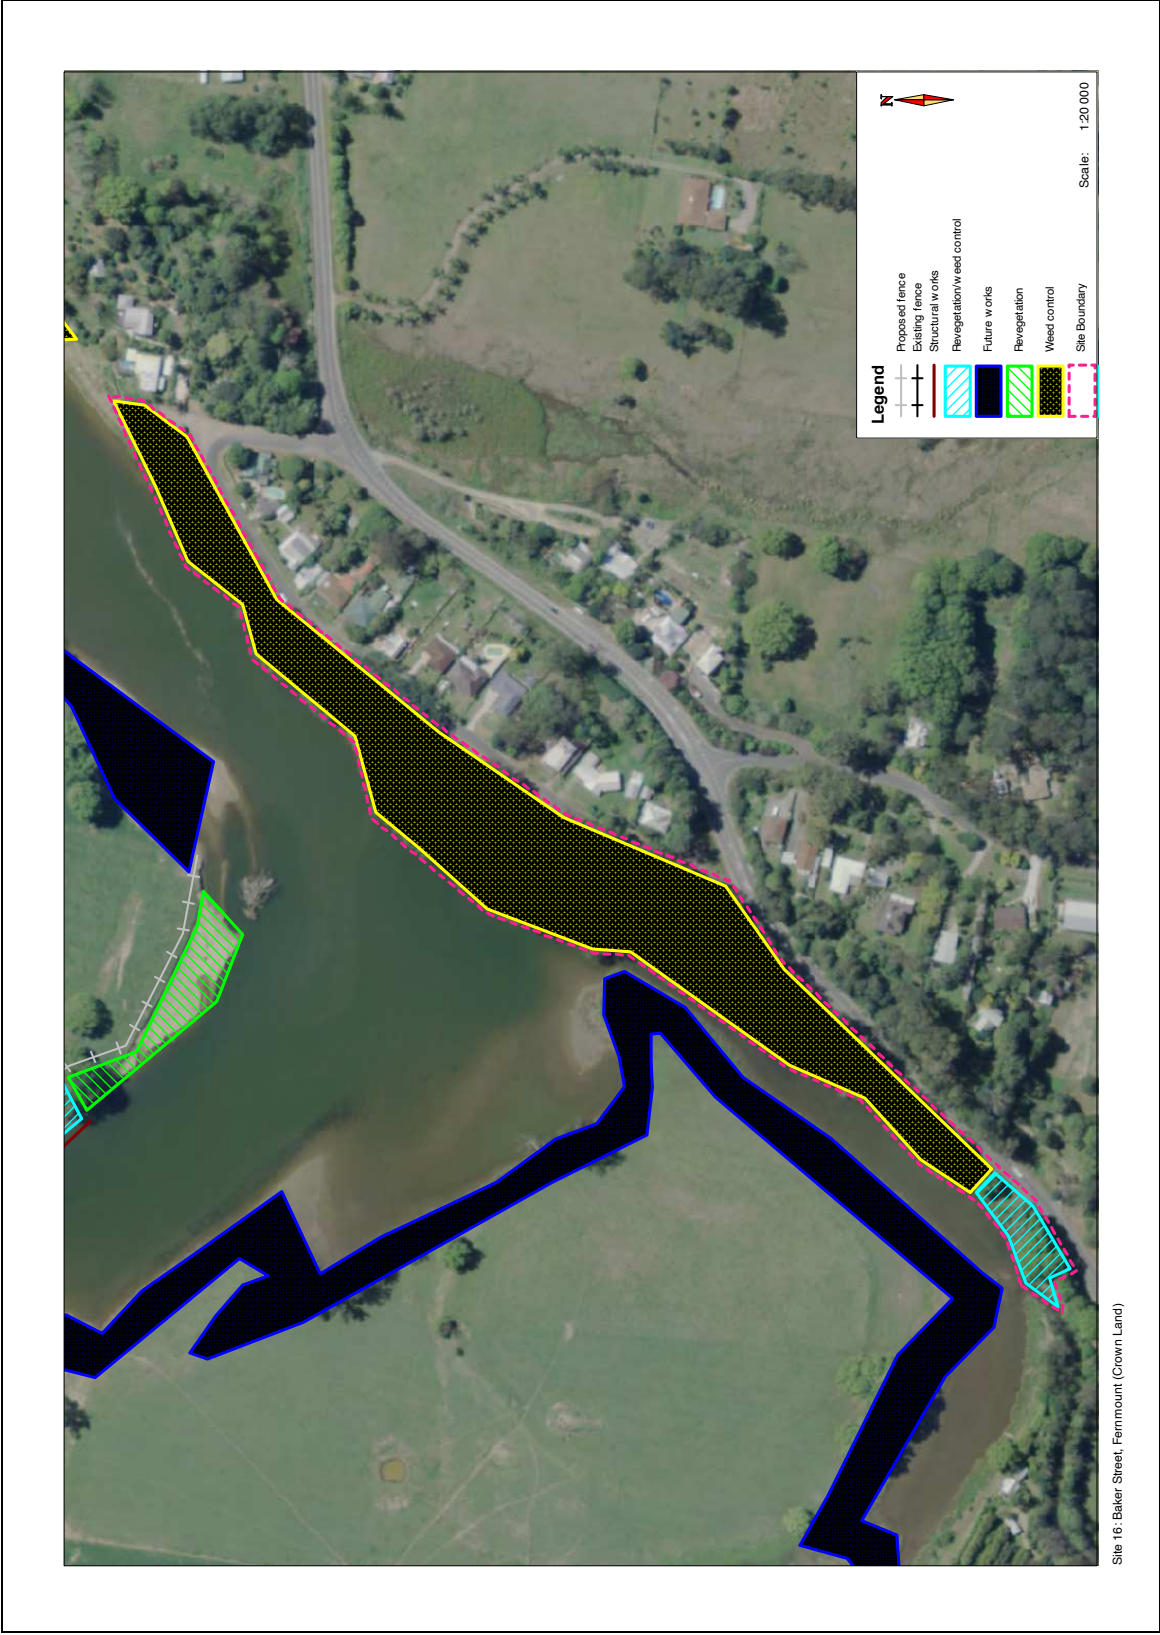
Figure 47: Property workplan map

1. The southwestern end of this site (zone x) is suffering from a severe vine weed infestation, with a sparse native vegetation understory. Targeted weed control and accompanying revegetation should be undertaken at this site. Follow-up treatment of vine weeds and ongoing weed management will also be critical to ensure the survival and recruitment of native plants.
2. The current weed control program should be expanded to both control invasive species and facilitate better native plant recruitment along the entire river bank at this site. This will require a broad scale, intensive initial weed control program and ongoing weed control to ensure the continued survival and recruitment of native plants.

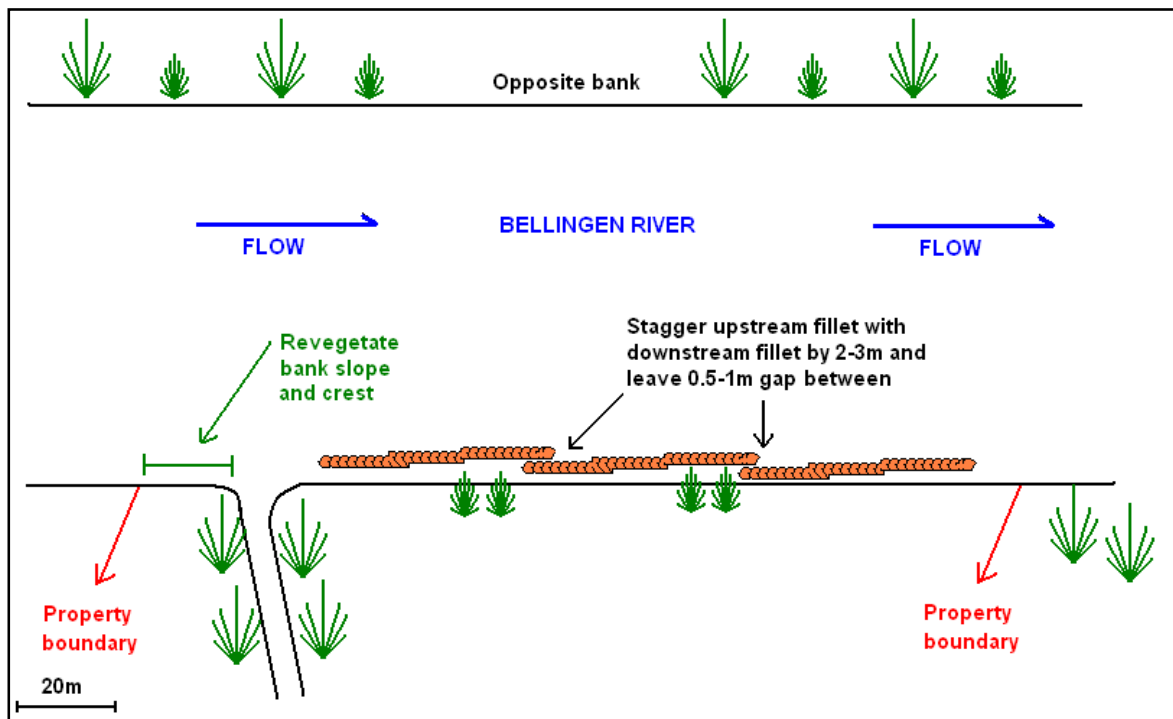
Figure 68: Design layout for structural works

1. A series of rock fillets (figure x) be placed along the low tide bench in order to facilitate the regeneration of mangroves and deflect damaging boat wash and flood scour. Should this option be undertaken, works would need to take place prior to any revegetation works suggest below.
2. The riparian area that is already fenced should be revegetated with deep rooted plant species as outlined in the Bellinger River Estuary Revegetation Guide (BSC/Bellinger Landcare). This will need to take place in conjunction with weed control work, in particular the Camphor Laurel (*Cinnamomum camphora*) trees will need to be removed in order to facilitate successful establishment of alternative native plants.

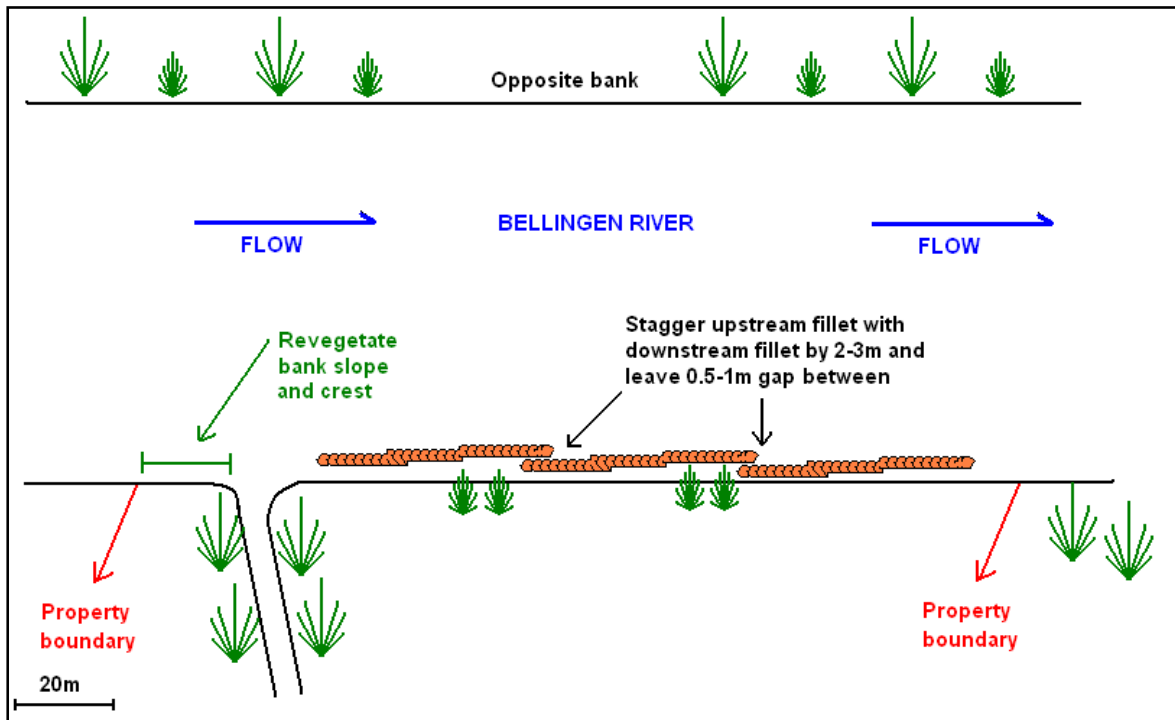
Figure 79: structural works diagram

2. Should undercut at the toe continue to cause bank retreat, installation of rock fillets (refer to figure x) would provide a higher degree of resilience against erosion from flooding and boat wash, however the cost would limit the potential for funding contributions from external parties.

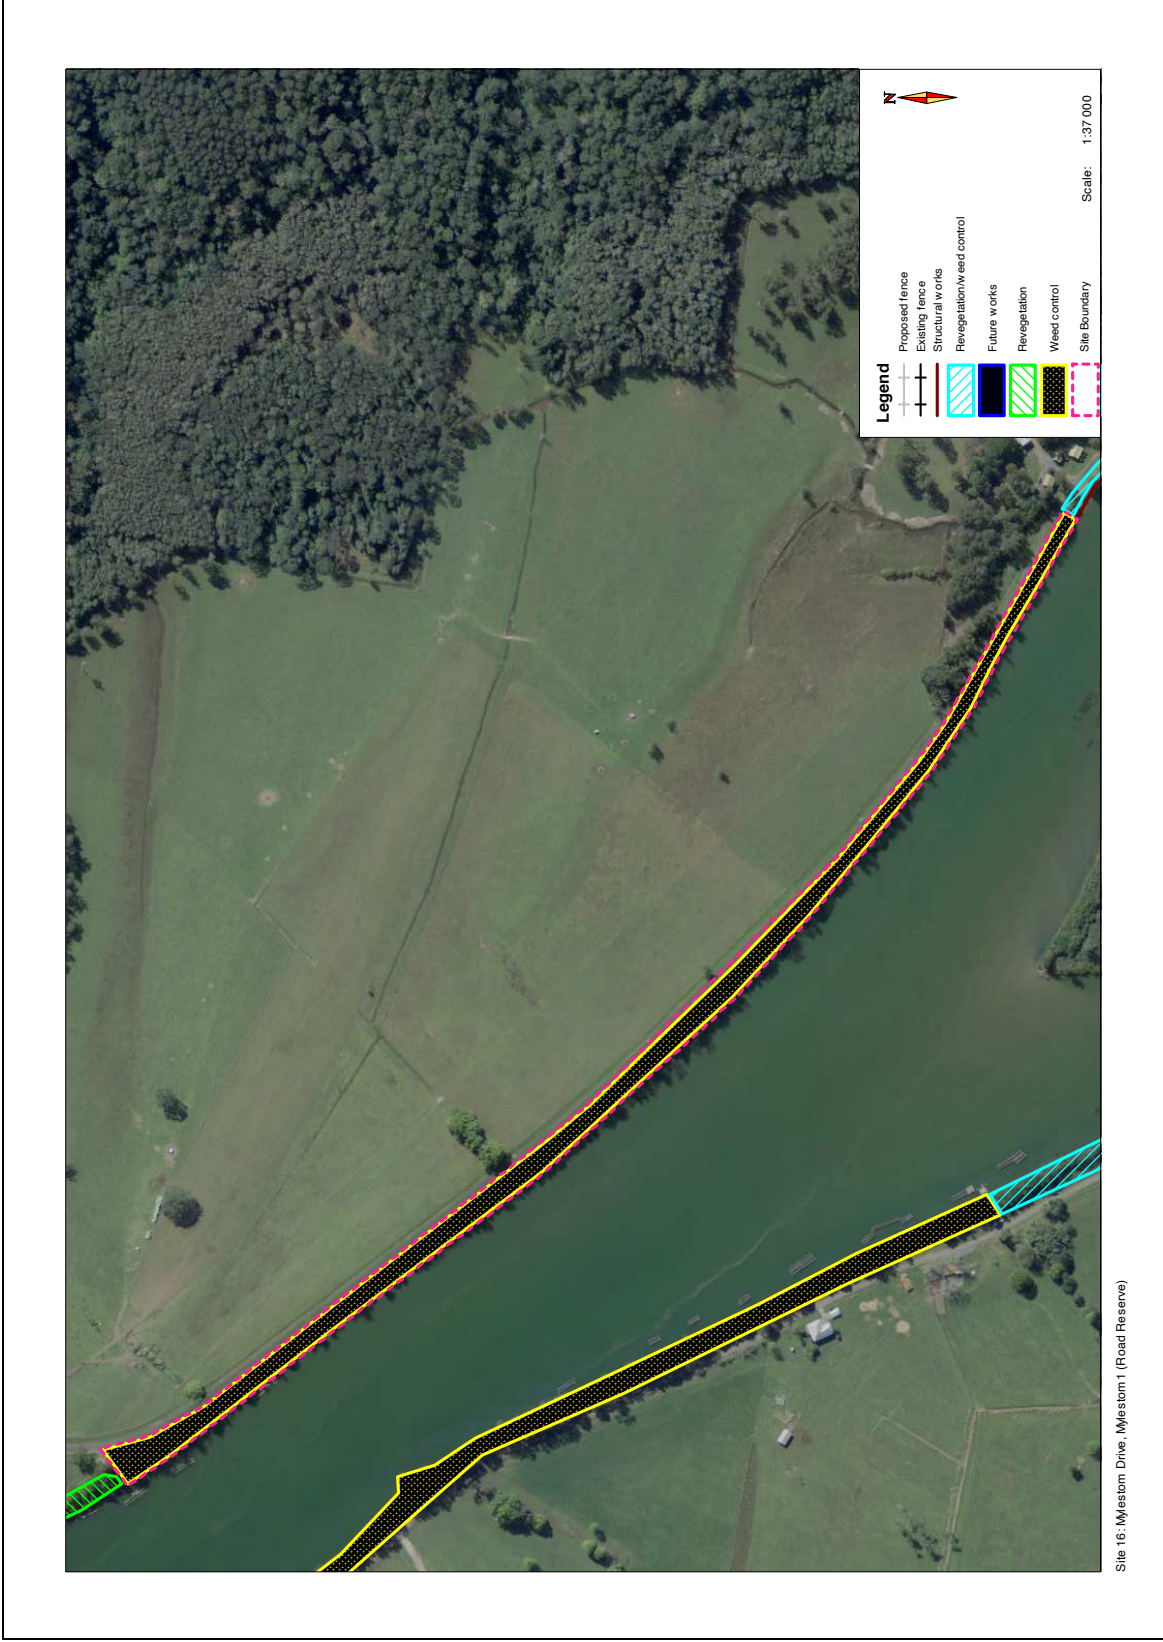
Figure 122: Property workplan map

The riparian corridor along this section represents one of the best examples of a target condition on the floodplain in the lower estuary therefore minimal intervention is necessary. It is recommended that periodic (e.g. biennial) weed control is undertaken to maintain this riparian zone in exemplary condition.

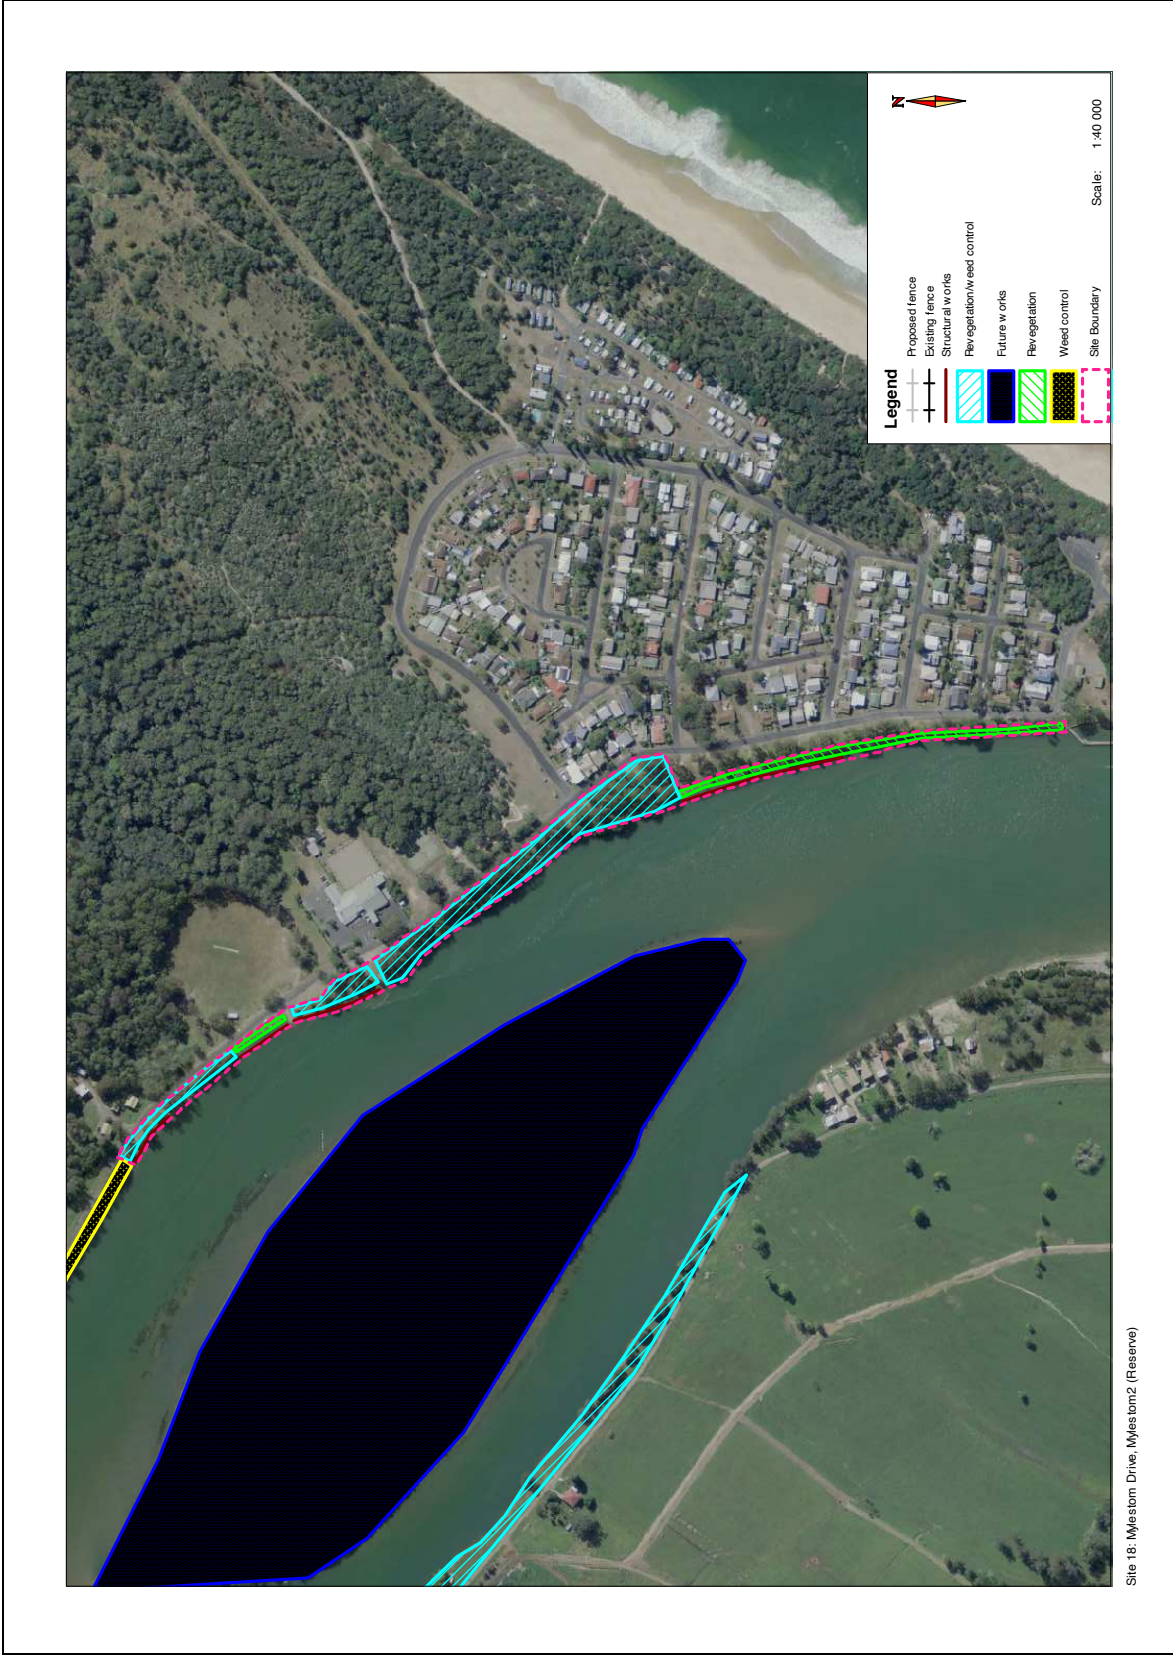
Figure 127: Property workplan map

Rehabilitation at this site should focus on ongoing control of problematic weed species. This should be coupled with revegetation to fill out gaps using deep rooted plants as outlined in the Bellinger River Estuary Revegetation Guide (BSC/Bellinger Landcare). This should be coupled with some plantings to reduce the bank slump potential and maintain the integrity of the retaining wall. Species such as Lomandra (*Lomandra longifolia*), River Lily (*Crinum pendiculatum*) and other shrub species would suffice while still maintaining the visual amenity of the River
